Subject: FRONT BRAKE CREAKING AT LOW SPEEDS	Bulletin No: 04-001/09
	Last Issued: 2/12/2009

2006-2007 MX-5 with VINs before JM1 NC**** ** 131172 (built before November 10, 2006)

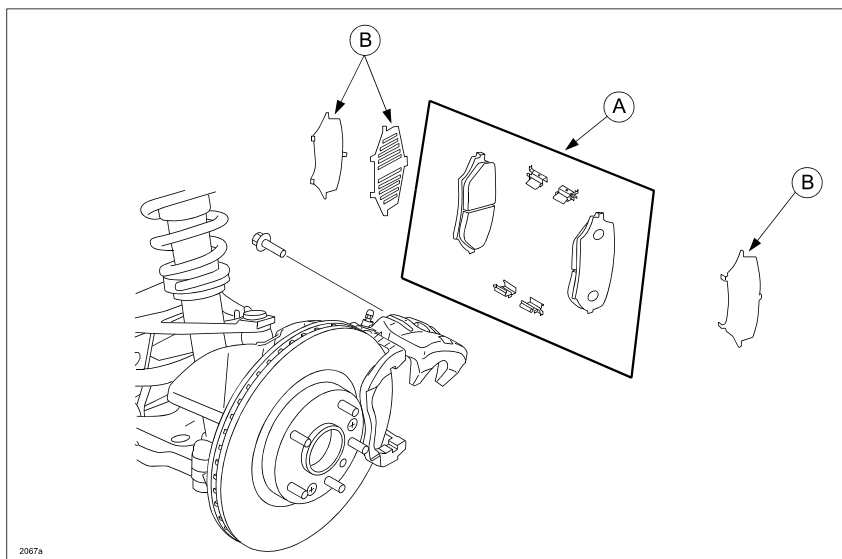
Some vehicles may exhibit a creaking noise when the brake pedal is gently depressed while driving at low speeds. The creaking noise is due to resonance of the front brake pad guide plate. The thickness of the guide plates have been increased to correct this concern.

1. Verify customer concern.
2. Replace front caliper pad sub set with modified parts (A). Refer to MS3 online service information or Workshop Manual section 04-11 DISC PAD (FRONT) REPLACEMENT. Reuse the existing attachment plates (shims) (B) when installing the modified parts.
