<b>Subject:</b>  WATER LEAK ABOVE SIDE WINDOWS	<b>Bulletin No:</b> 09-036/06
	<b>Last Issued:</b> 9/1/2006

2006 MX-5 vehicles with VINs lower than JM1 NC\*\*\*\* \*\* 111535 (produced before December 27, 2005)

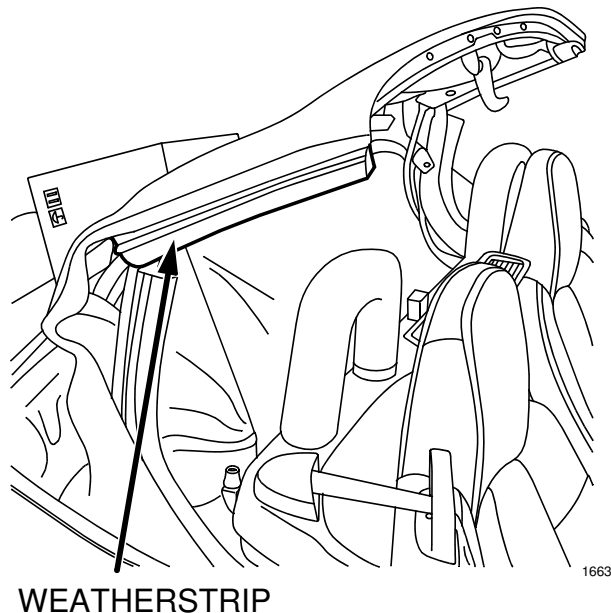
Some vehicles may experience water leaks into the vehicle cabin from under the weather-strip above the side windows. As a mass production change, the sealing of the soft top cloth at the weather-strip retainer has been improved.

- The water leak addressed in this bulletin is between the weather-strip retainer and the soft top, NOT between the weather-strip and the window.
